Circular 132-AN/93

### AIRCRAFT ACCIDENT DIGEST No. 21

Japan Air Lines, DC-8-62, JA-8040, accident at Moskva/Sheremetievo, USSR, on 28 November 1972. Report not dated, released by the Deputy Minister of Civil Aviation of the USSR

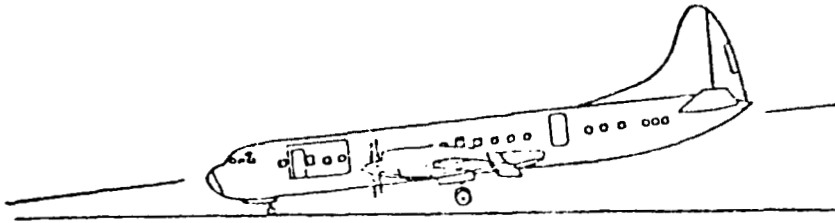
The Electra at impact with nose oleo fully compressed and about to punch through the ice.

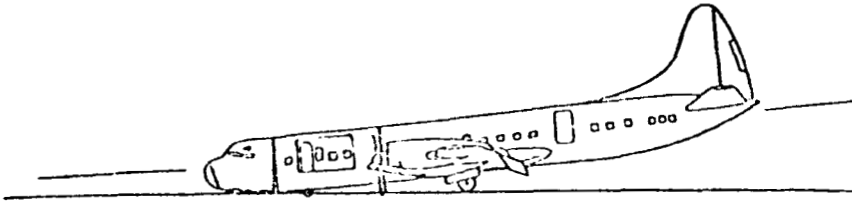
The main gear penetrates the ice, the outboard propellers begin to slash the ice and the nose gear truss girders and shock tube tear out with the fuselage rupturing at FS 200.

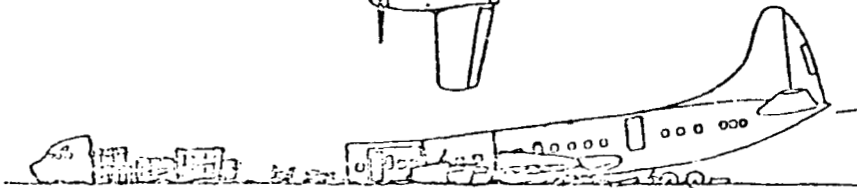
The nacelles and wing centre box contact the ice, the propellers, gearbox and engines separate from the wings, the fuselage ruptured at FS 570, the right wing exploded outboard of WS 170, the left wing separated intact outboard of WS 170 and the centre wing box disintegrated. The cockpit and bulk cargo slid ahead of the decelerating structure, and the passengers, seats and emergency gear cabinet broke free within the aft fuselage.
